24<sup>th</sup> August 2021

**Re: Specific Structural Inspection of 'Calder Crossing' Footbridge at The Lammas Land & recommendations.**

The traditionally constructed footbridge ('Calder Crossing') spans over Crane Brook and is formed with treated hardwood, thought to have been constructed approximately 20 years ago. The bridge runs from east-south-east (A) to west-north-west (B). The bridge allows pedestrian, wheelchair and pushchair access.

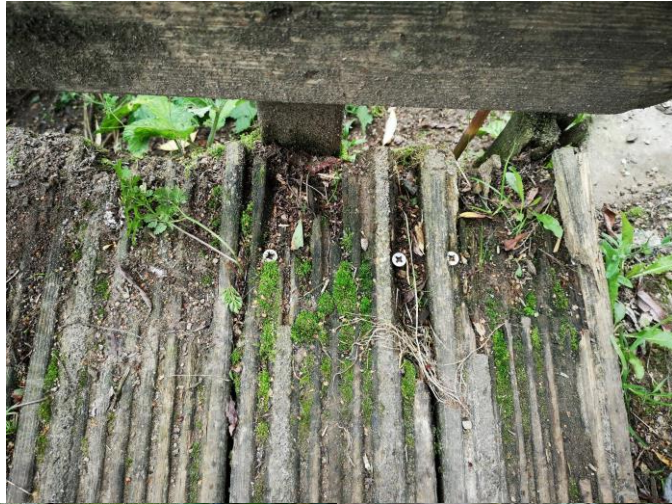
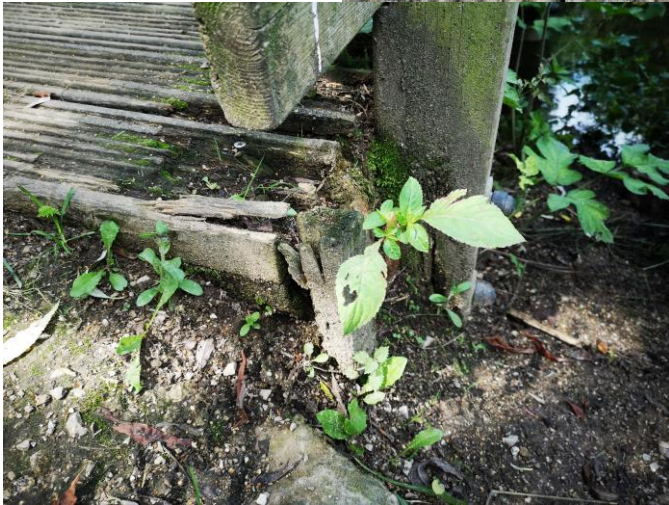
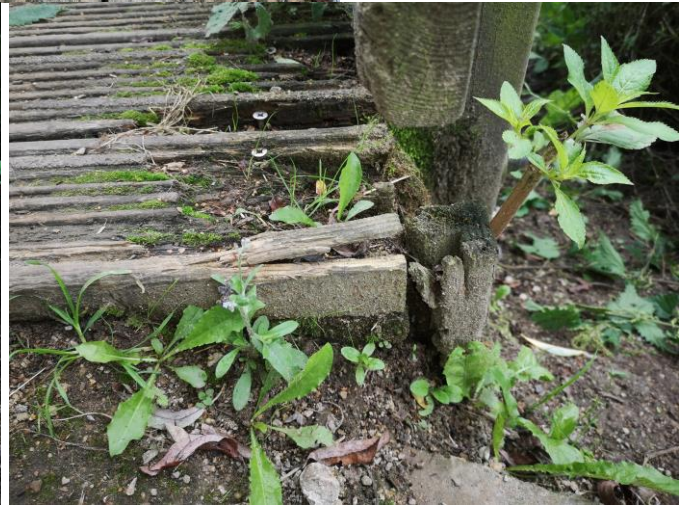
3. At point A, the front right-hand post and adjacent timber decking is suffering from wet rot. Please see attached photograph and diagram area 1.
4. At point B, the front right-hand timber decking and minor adjacent timbers are suffering from wet rot. Please see attached photograph and diagram area 2.

VIEWPOINT A – WET ROT AT LOW-LEVEL TO FRONT RIGHT-HAND AREA TO TIMBER DECKING & ADJACENT TIMBER POST. (SEE DIAGRAM POINT 1)  
GROUND FALLEN AWAY ADJACENT TO BRIDGE ABUTMENT.

- The bridge should be carefully jet washed/cleaned off.
- All timber decking affected by wet rot (c. 10no.) should be replace accordingly as soon as practicable to avoid inevitable failure. All replacement timber should be pre-treated.
- Wet rot to the corner posts at point A and B is not considered severe although it is likely to be more cost effective replacing the posts rather than localised splice repairs etc. Elsewhere posts remain in satisfactory condition.
- All yellow moss to the underside of the bridge should be eradicated accordingly as soon as practicable.

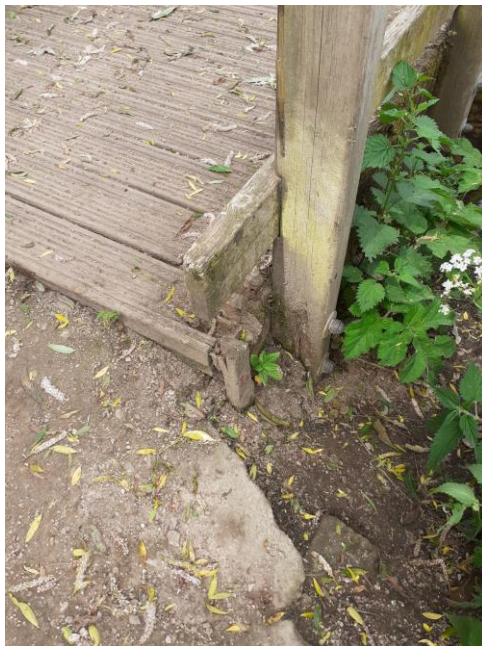
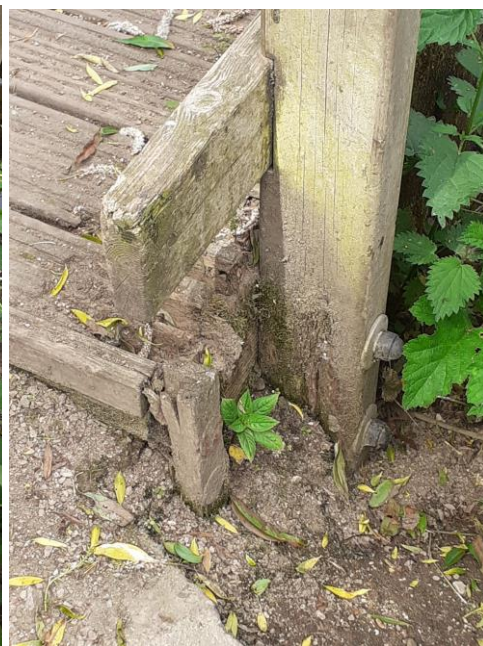
VIEWPOINT A – WET ROT AT LOW-LEVEL TO FRONT RIGHT-HAND AREA TO TIMBER DECKING & ADJACENT POST. (SEE DIAGRAM POINT 1).

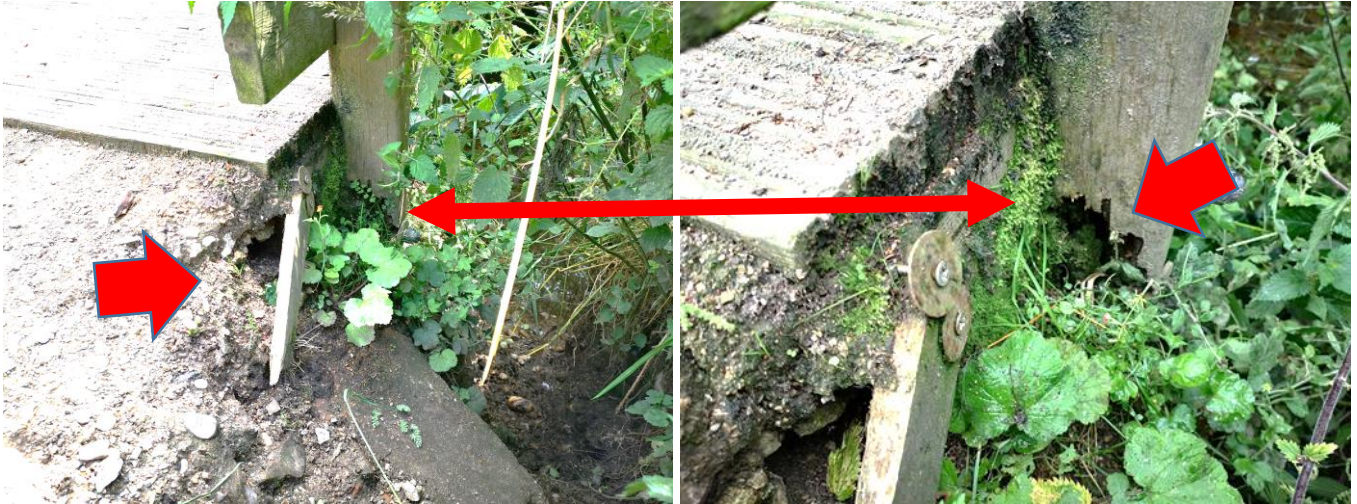
VIEWPOINT B – WET ROT AT LOW-LEVEL TO FRONT RIGHT-HAND CORNER POST.  
(SEE DIAGRAM POINT 2)  
GROUND FALLEN AWAY ADJACENT TO BRIDGE ABUTMENT.

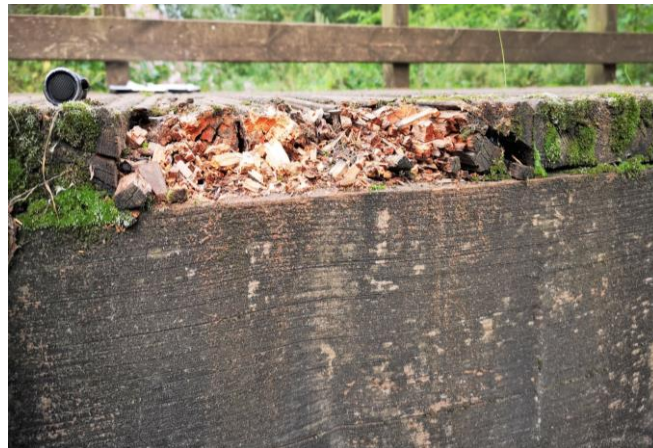
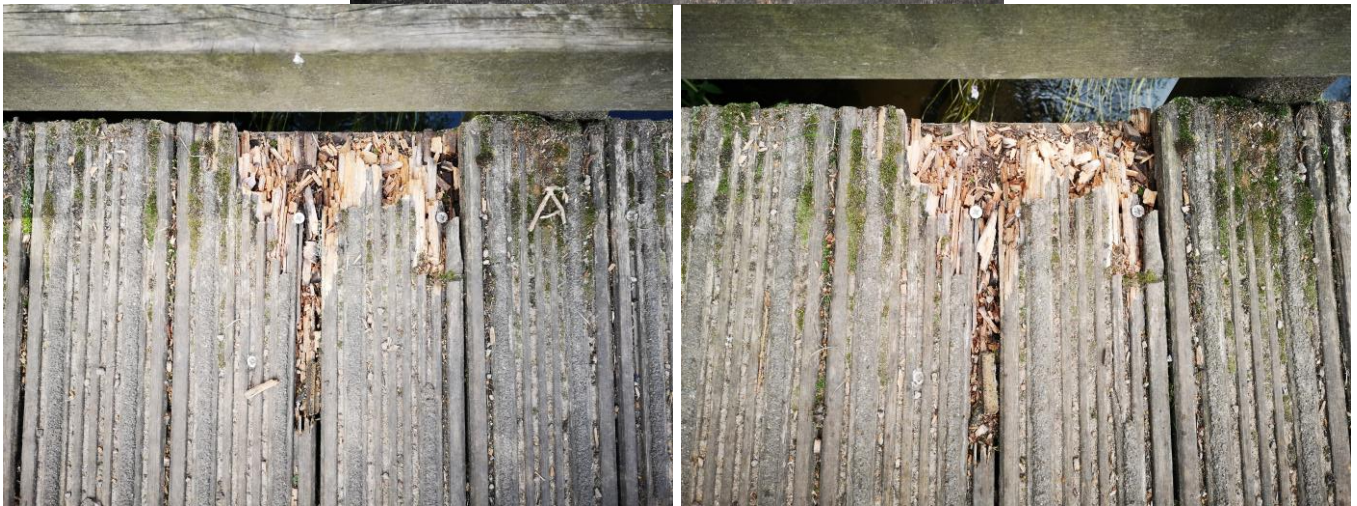
5. Timber decking at mid-point (facing upstream) is suffering from wet rot. Please see attached photographs and diagram area 3.
6. Several areas to the underside of the timber decking are noticeably damp and are harbouring yellow moss. Please attached photographs. Elsewhere several areas are also home to green moss.

MID-POINT FACING UPSTREAM - WET ROT TO TIMBER DECKING. (SEE DIAGRAM POINT 3).

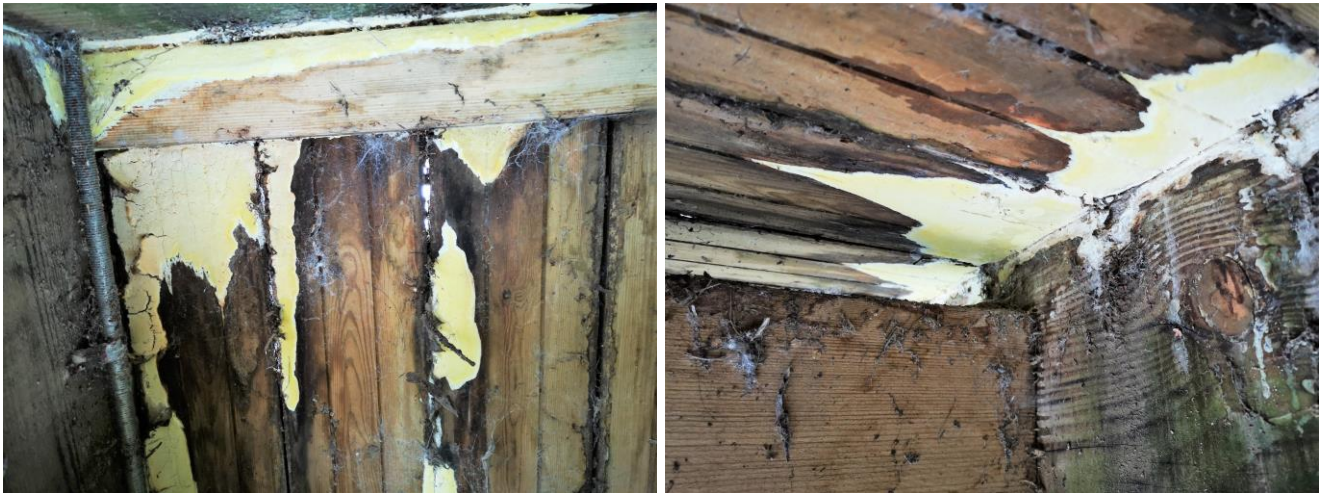
MID-SECTION - EXAMPLE OF YELLOW MOULD TO DAMP AREAS.
